Technical Report CERC-96-8
September 1996

Periodic Inspection of Burns Harbor North Breakwater, Indiana

Report 1 Base Conditions

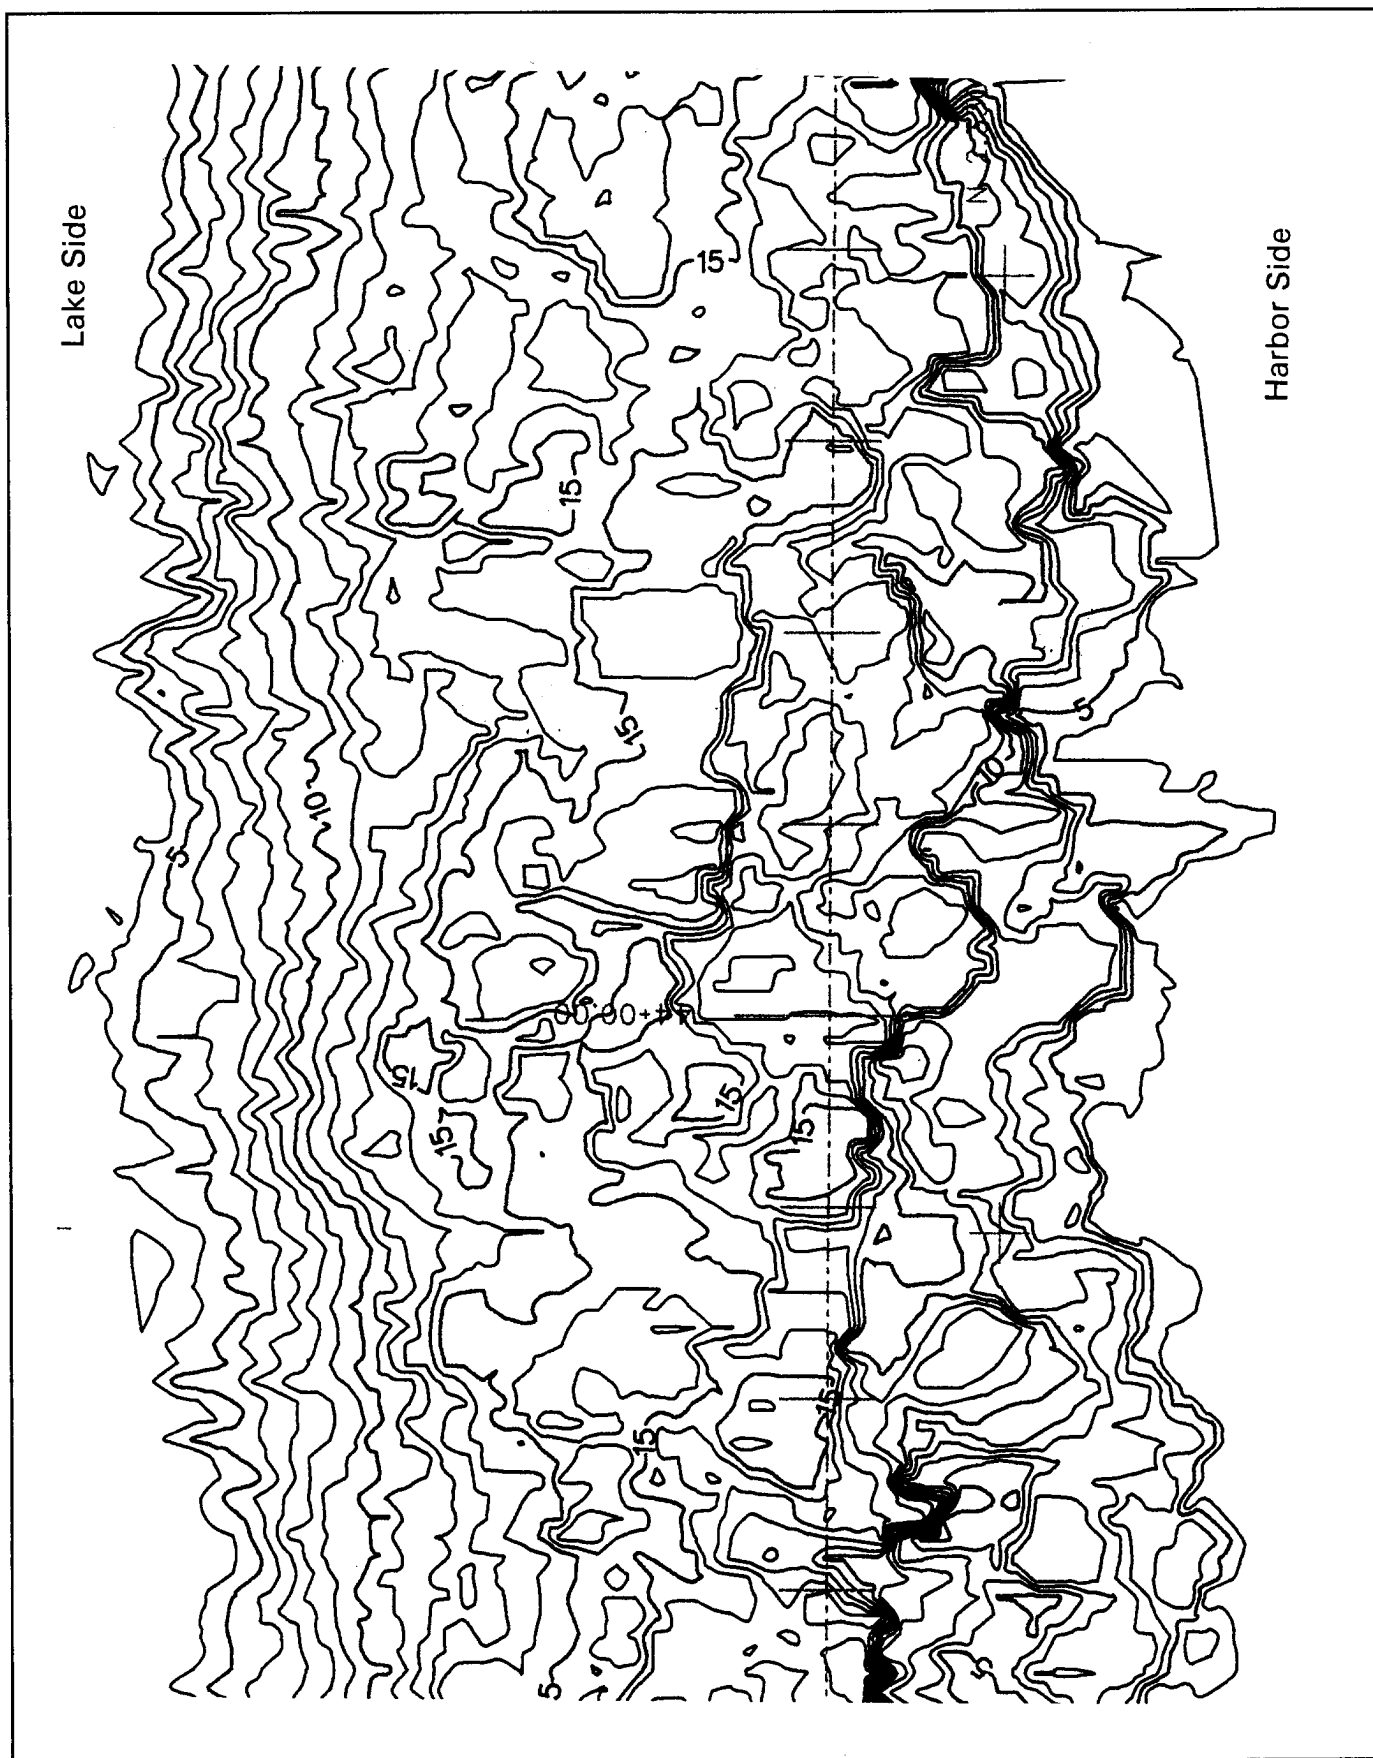
Figure A52. Topography of Burns Harbor North Breakwater, sta 43+51-44+36

This appendix presents contour maps of the Burns Harbor North Breakwater. Topography was developed using the digital terrain model (DTM) as stated in the main text of this report. The breakwater topography is shown on a 0.3-m (1.0-ft) contour interval. Elevations shown are in feet referred to low water datum (lwd). To convert them to meters, multiply by 0.3048. Station numbering on the contour maps is from east to west (right to left). The scale of the maps is 25.4 mm = 3.05 m (1 in = 10 ft).

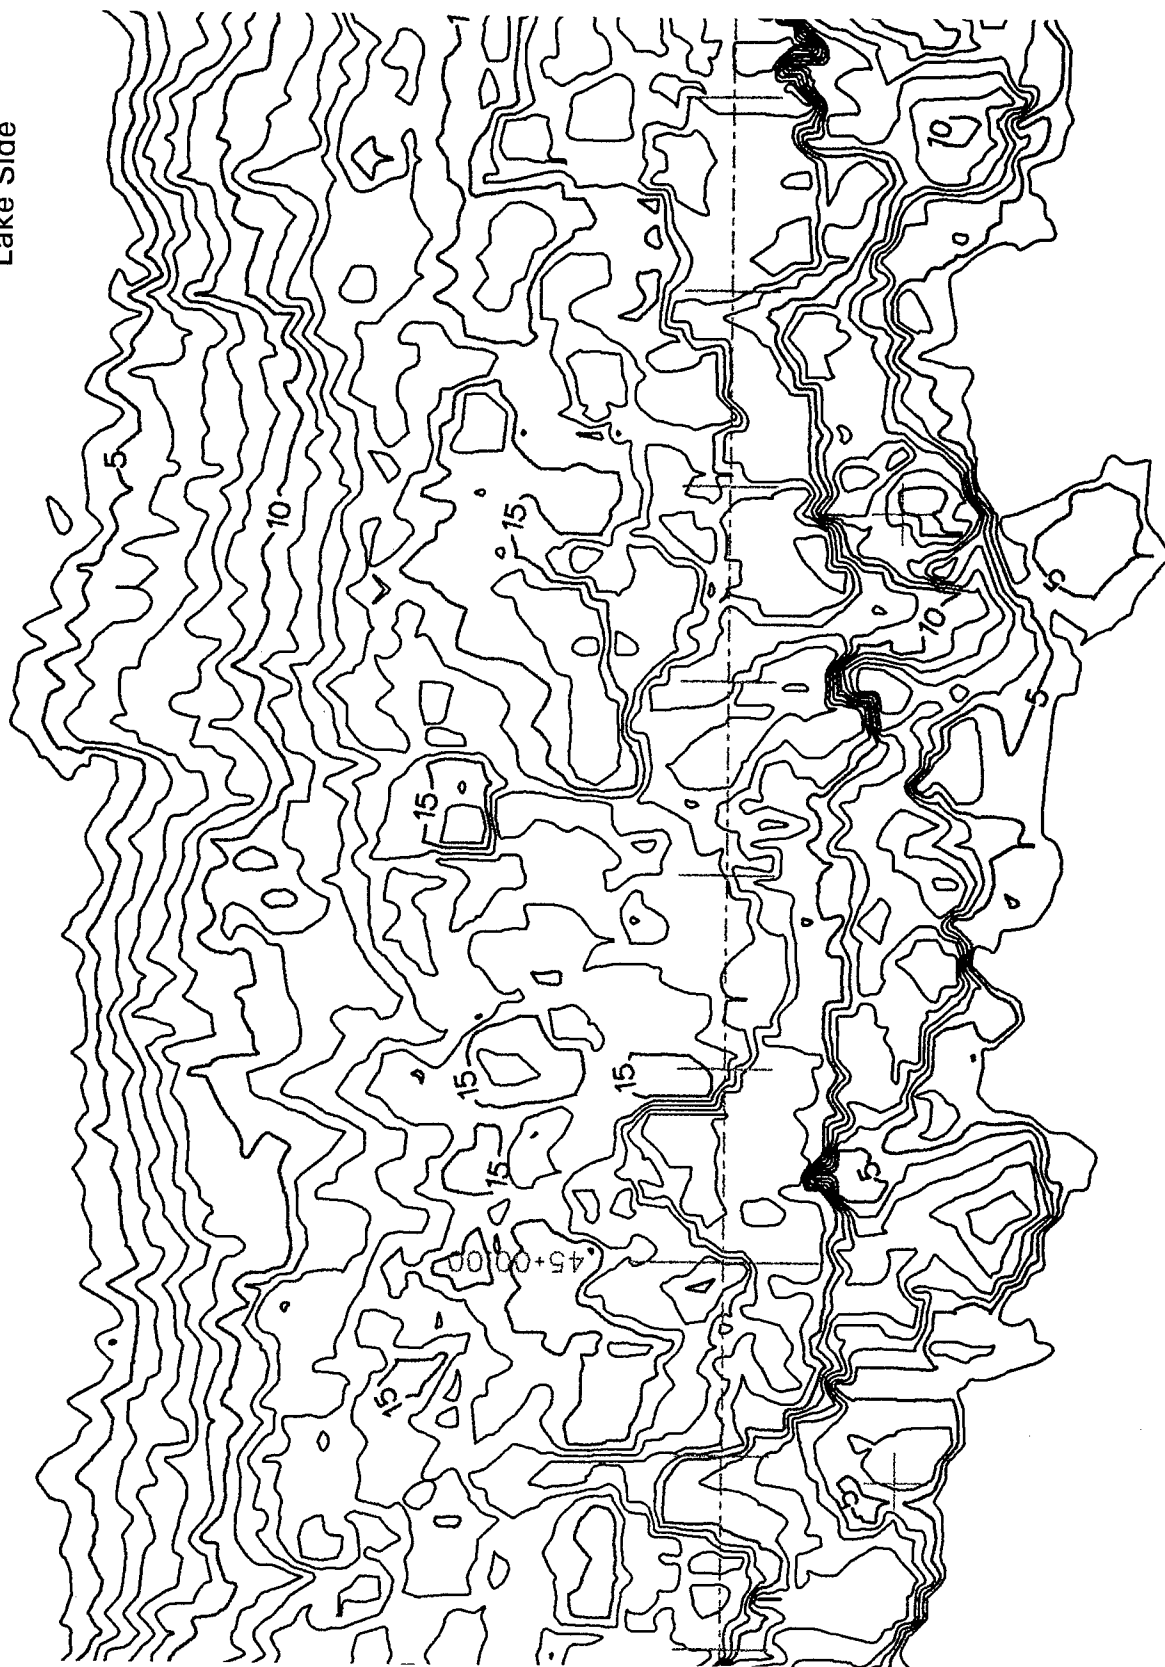
Figure A53. Topography of Burns Harbor North Breakwater, sta 44+36-45+21

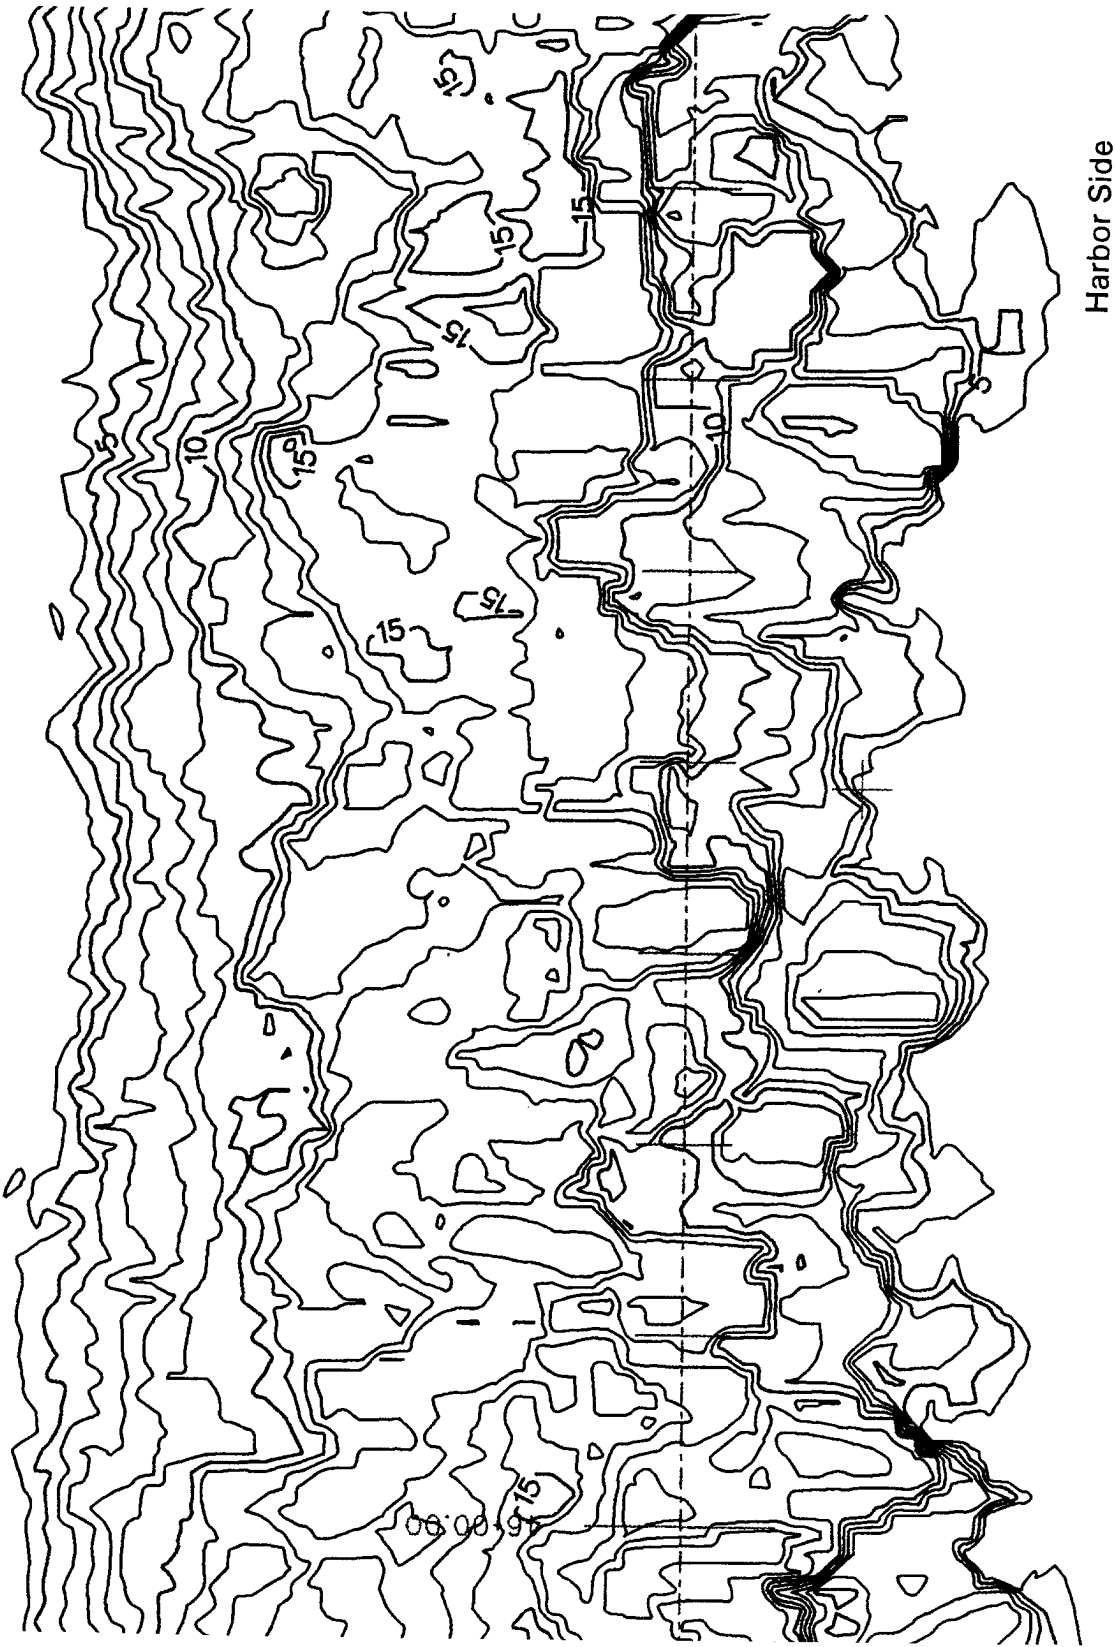
Figure A54. Topography of Burns Harbor North Breakwater, sta 45+21-46+06

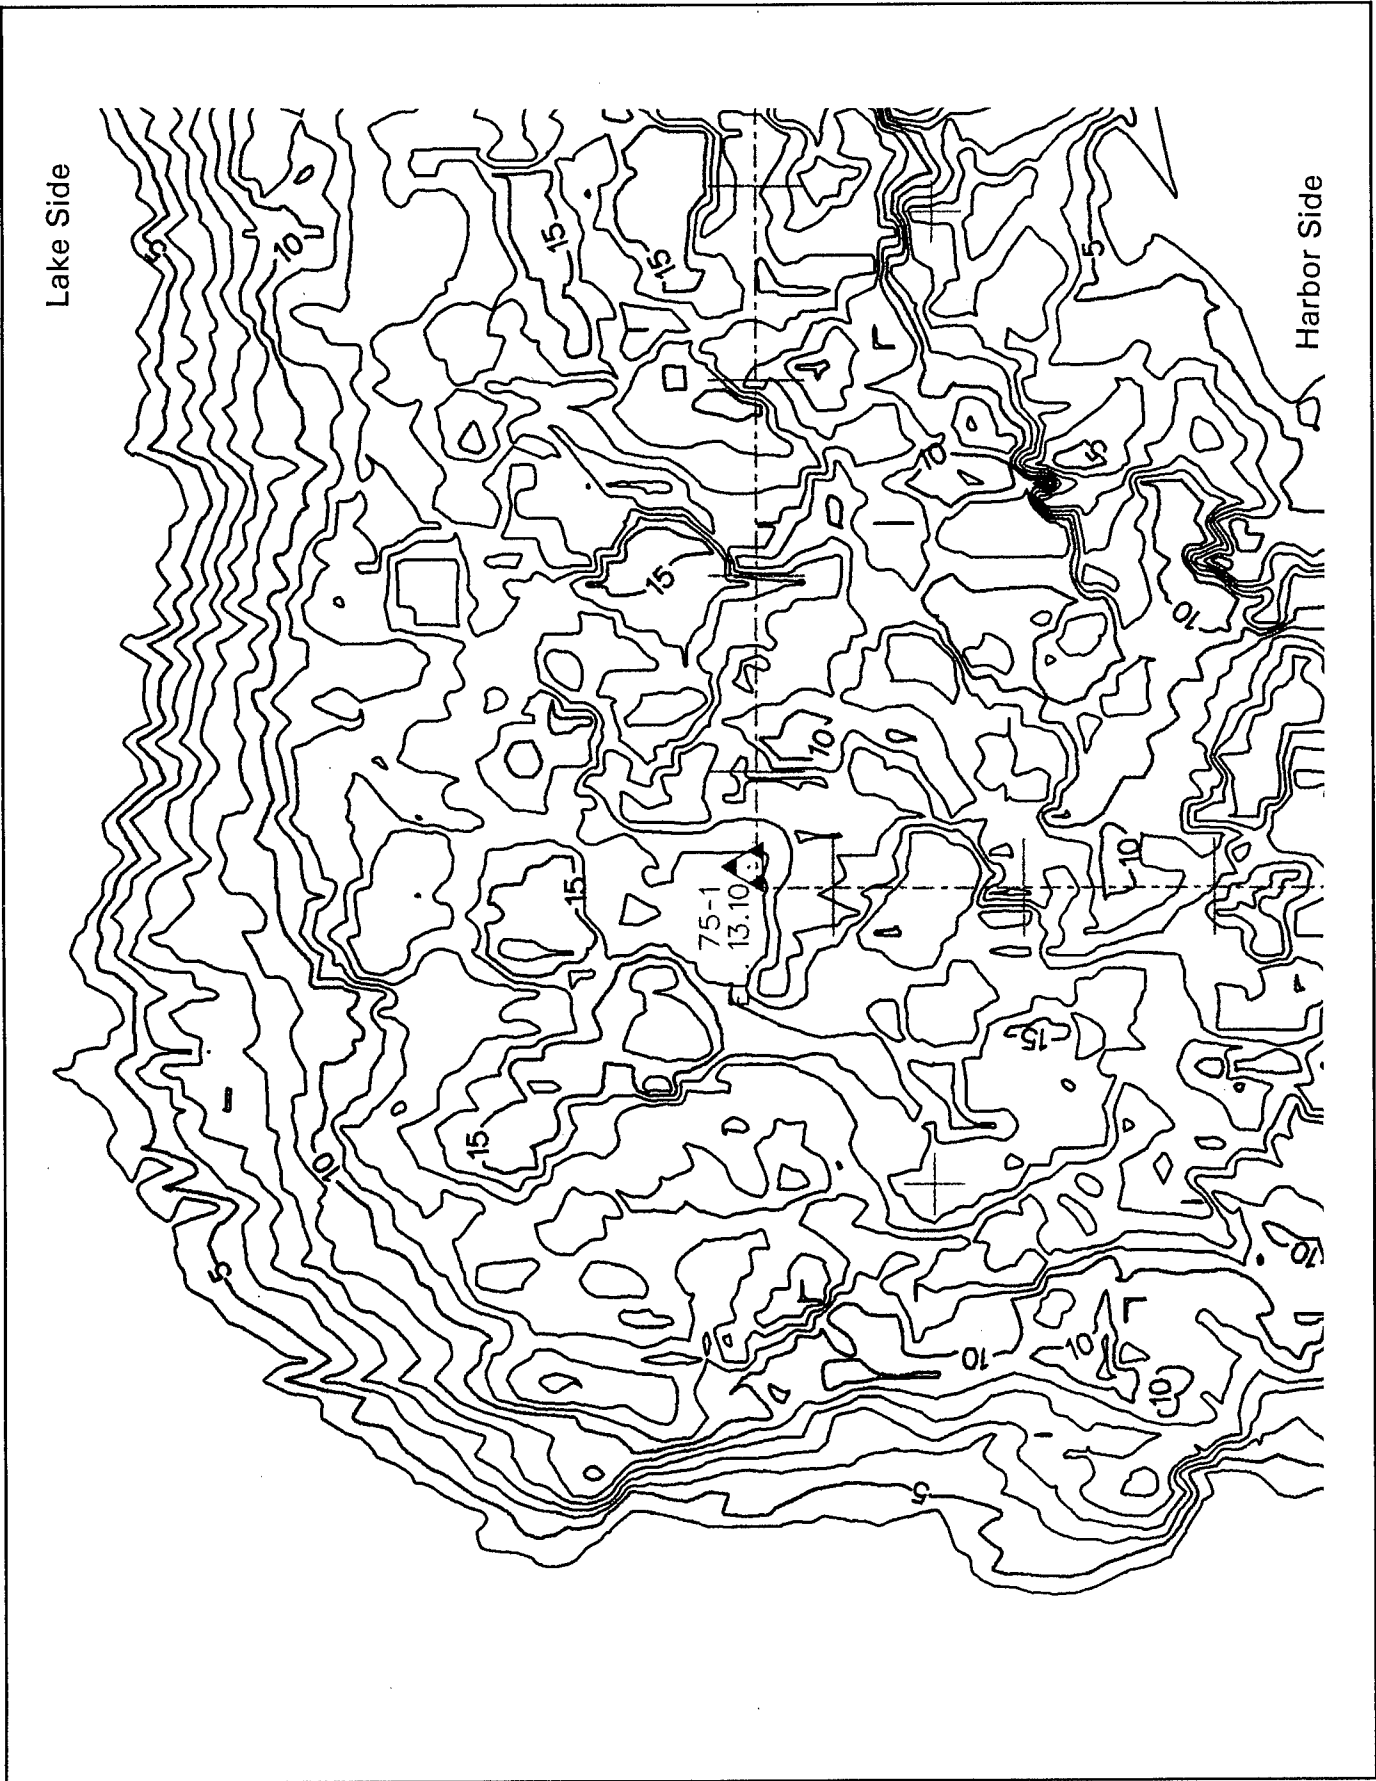
Figure A55. Topography of Burns Harbor North Breakwater, sta 46+06-46+40

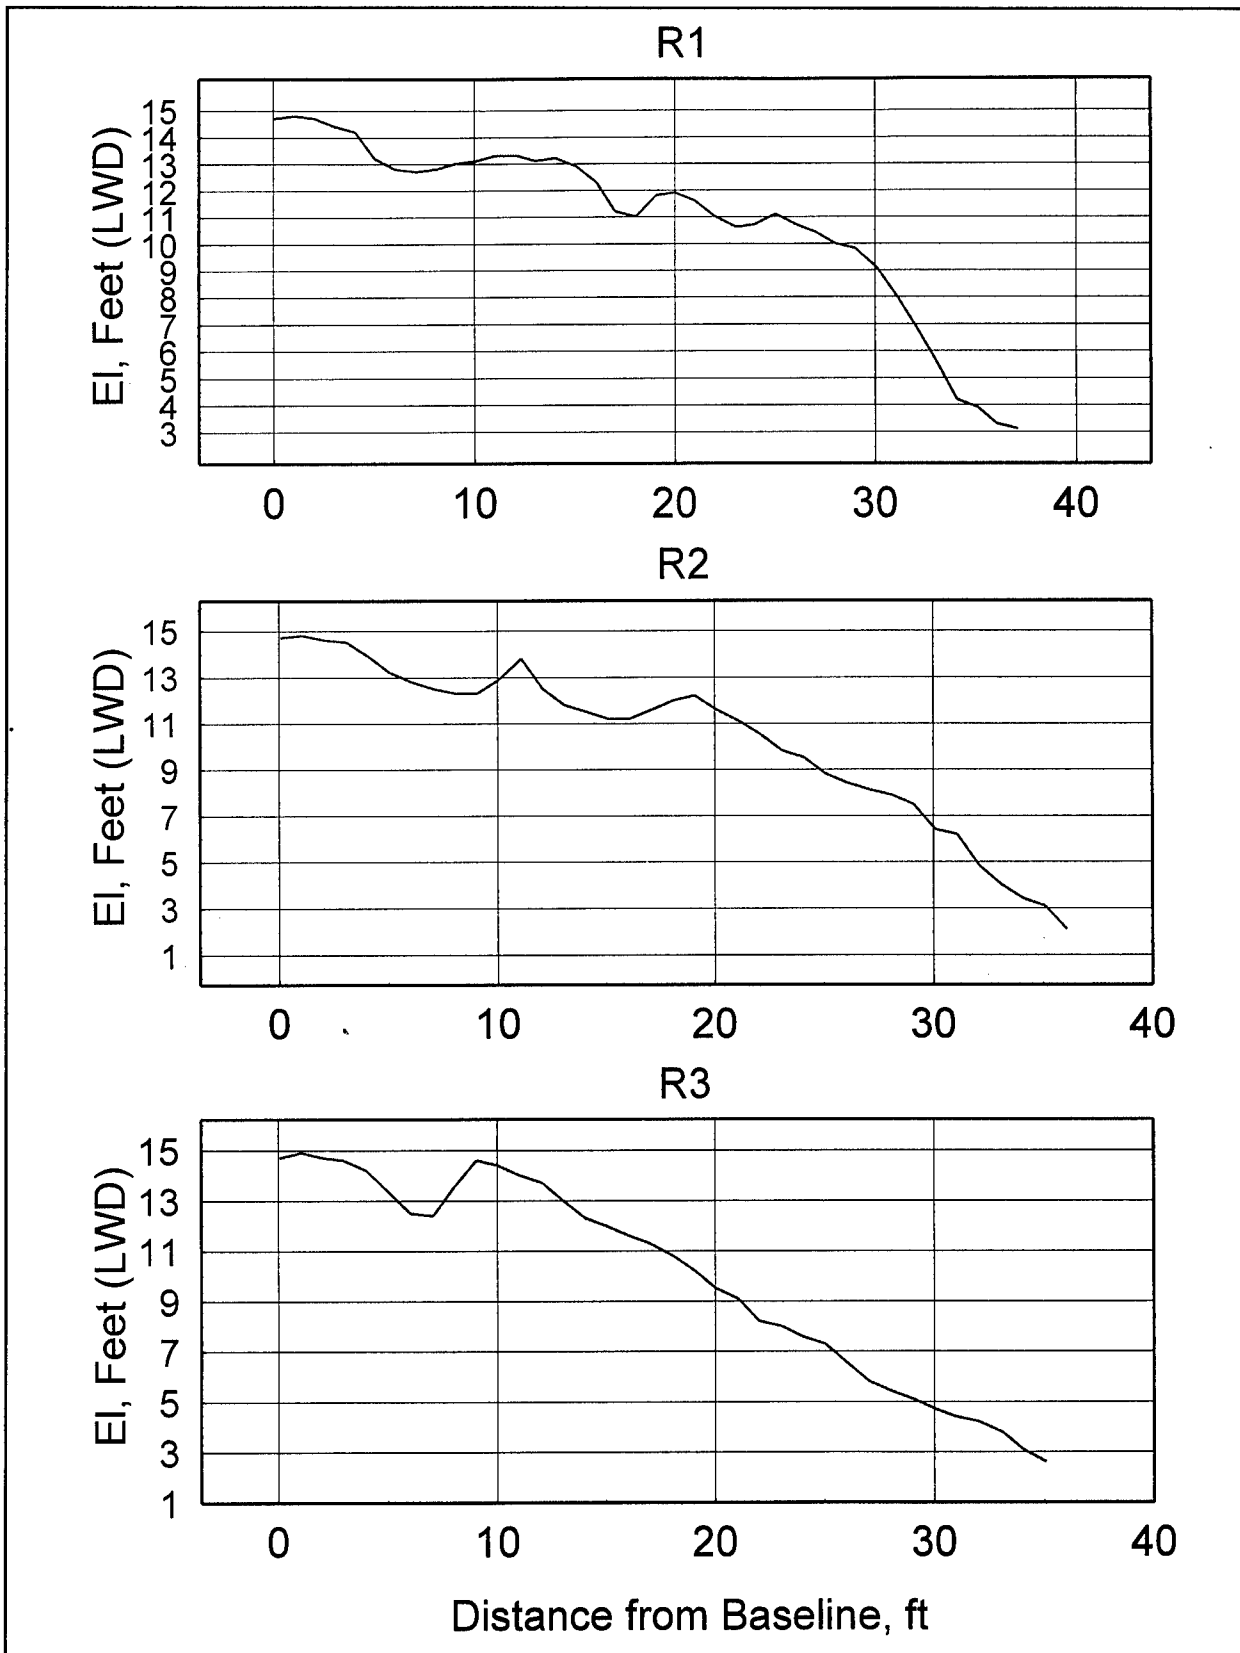
Figure B1. Cross sections of Burns Harbor North Breakwater, sta R1, R2, and R3

This appendix presents cross sections of the Burns Harbor North Breakwater. Cross sections were developed using the digital terrain model (DTM) grid as stated in the main text of this report. They were obtained at 0.3-rad (15-deg) intervals around the head of the breakwater and 15.2-m (50-ft) intervals along the trunk as shown in Figure 10 in the main text of this report. Elevations shown are in feet referred to low water datum (lwd). To convert them to meters, multiply by 0.3048. Distances from the baseline also are shown in feet and may be converted to meters using the same factor. The baseline established was the approximate center line of the breakwater. Negative distances are measured relative to the harbor side of the baseline and positive distances are measured relative to the lake side of the baseline.

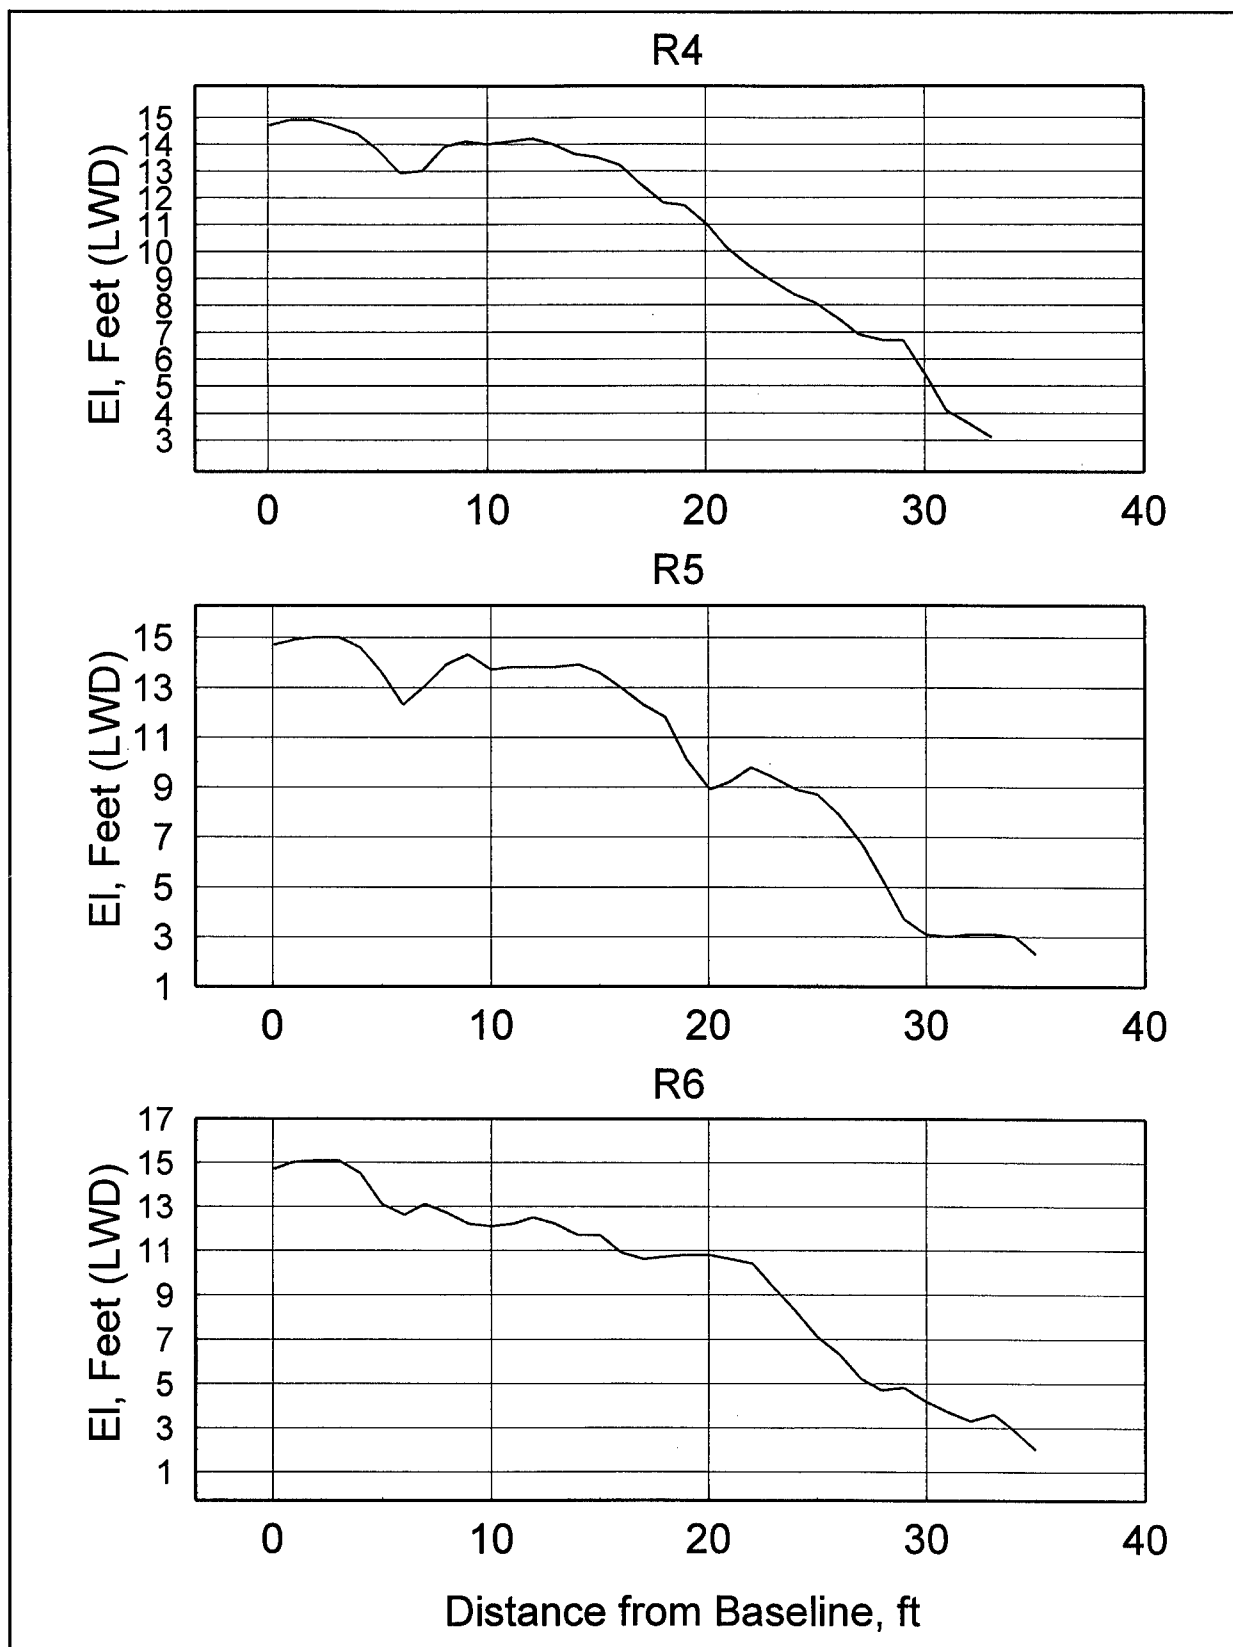
Figure B2. Cross sections of Burns Harbor North Breakwater, sta R4, R5, and R6

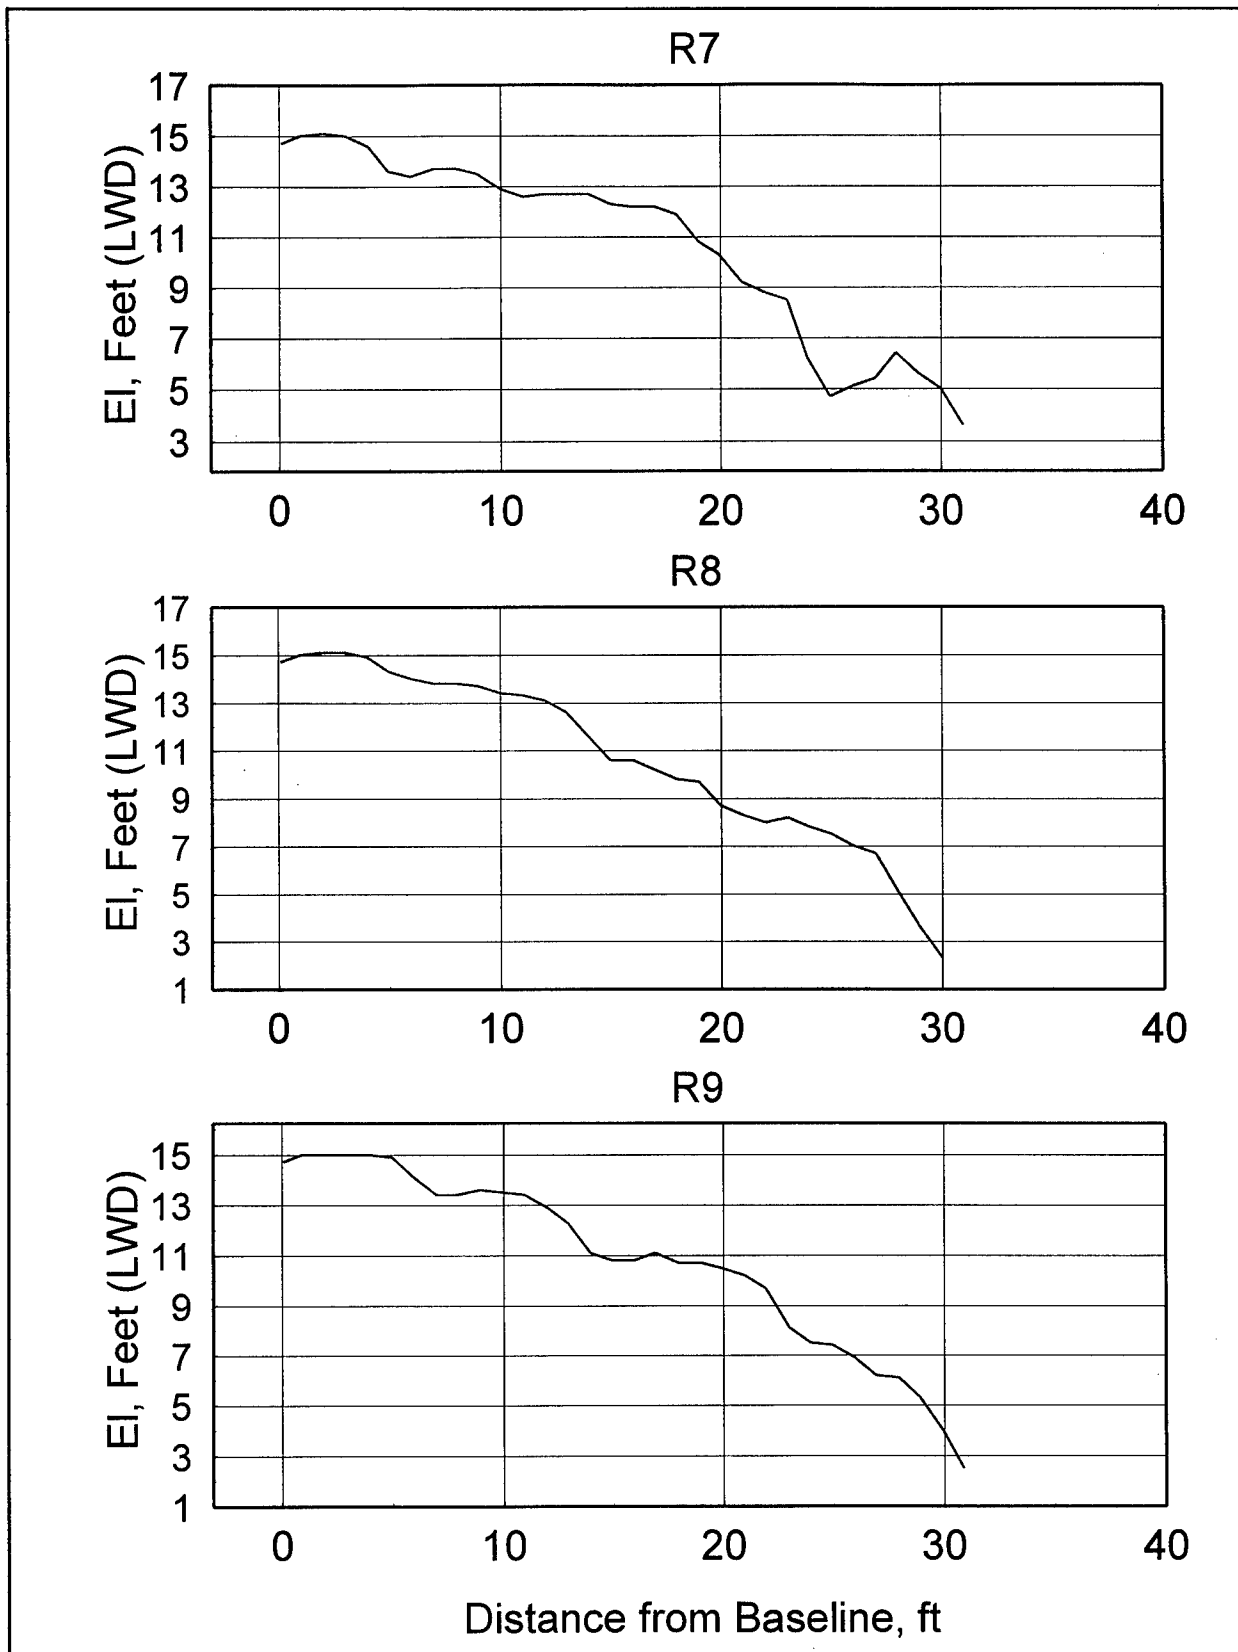
Figure B3. Cross sections of Burns Harbor North Breakwater, sta R7, R8, and R9

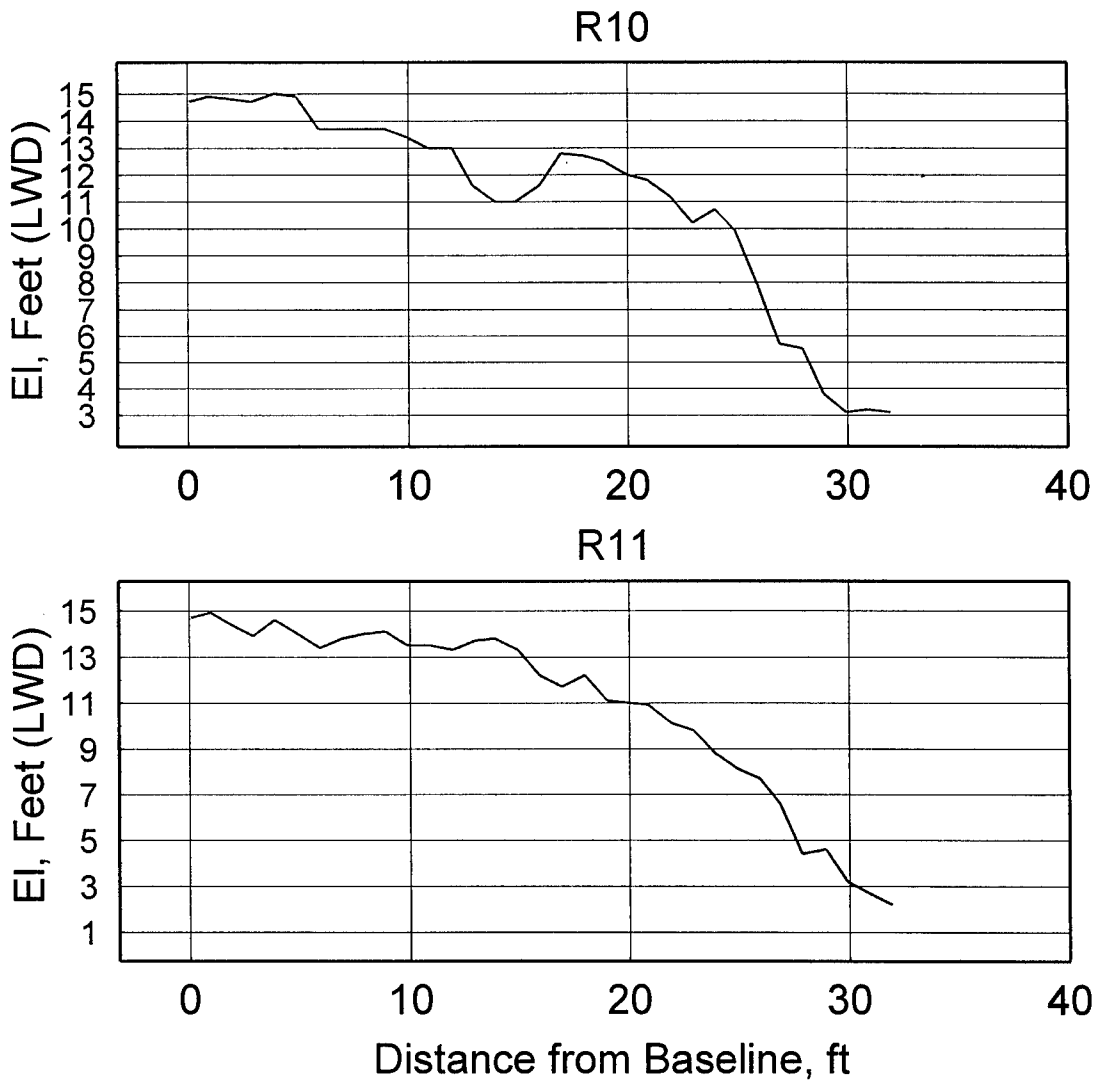
Figure B4. Cross sections of Burns Harbor North Breakwater, sta R10 and R11

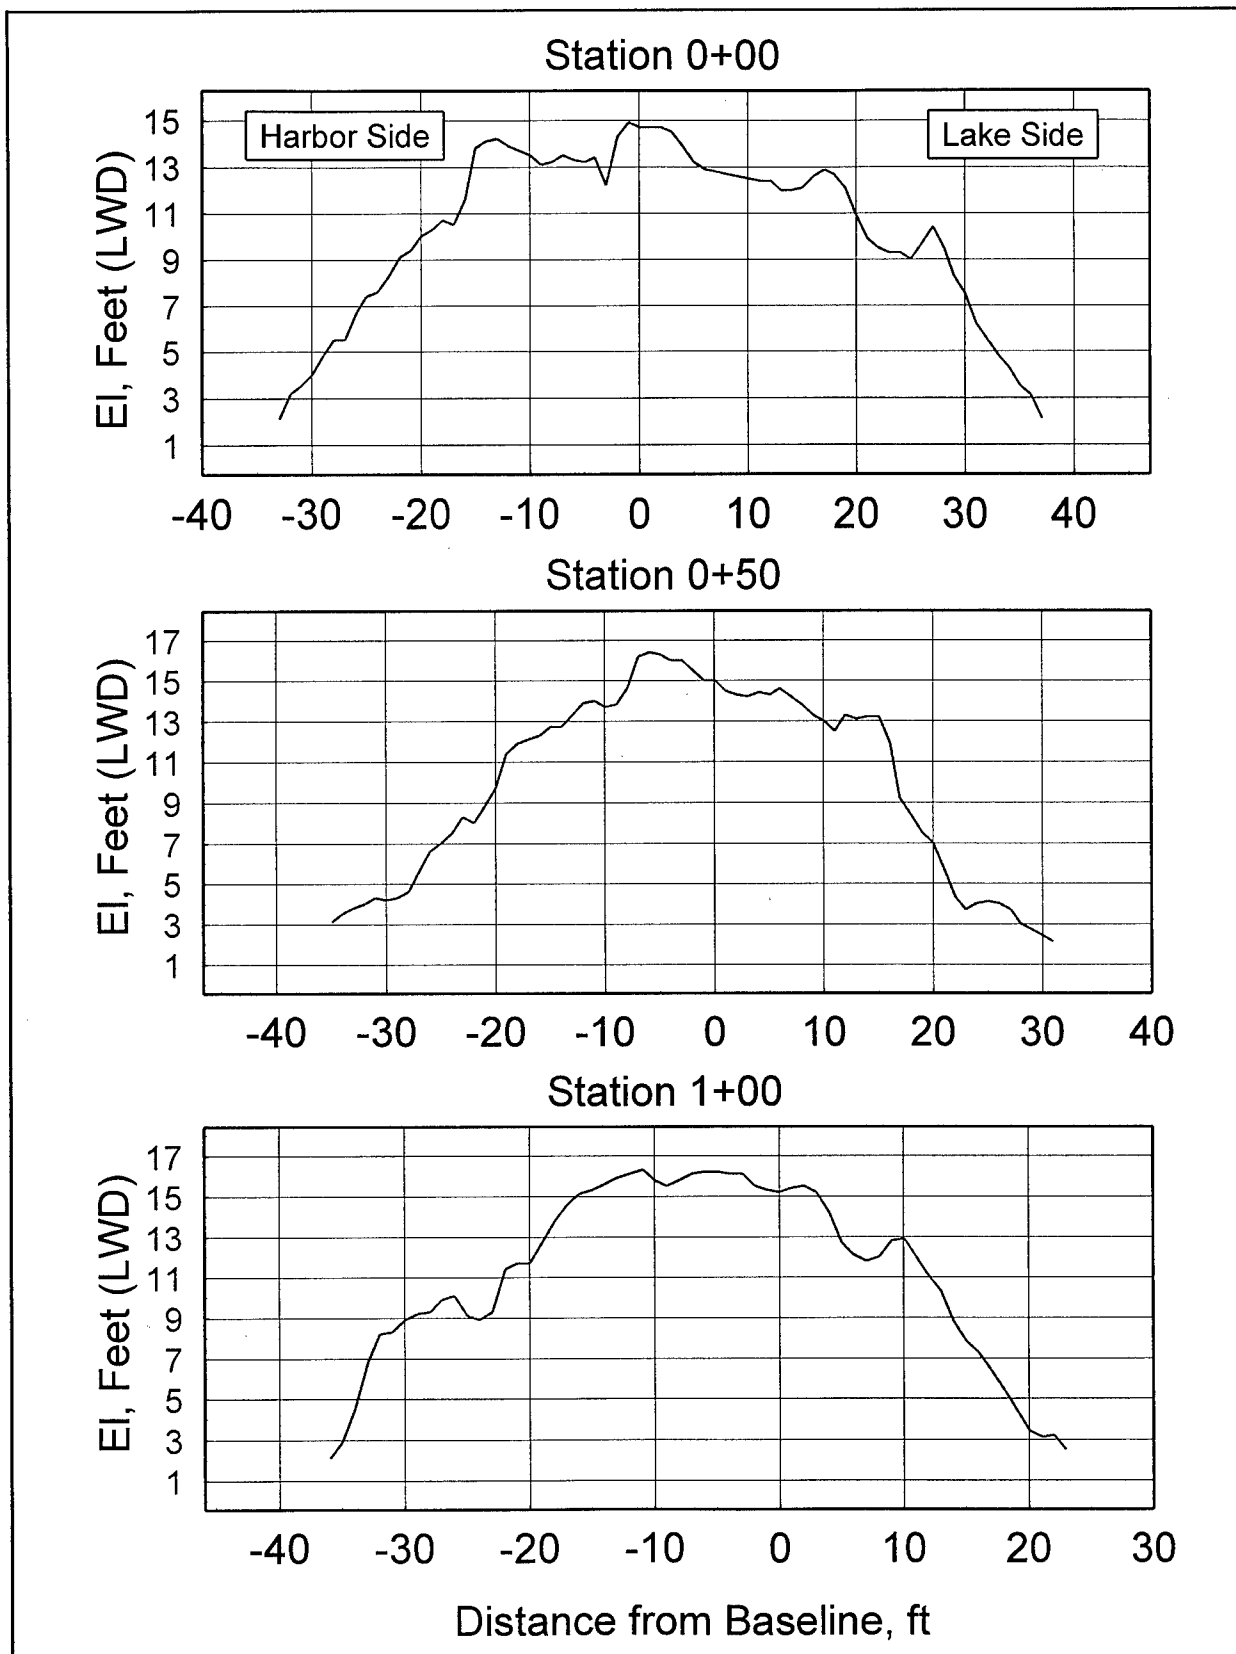
Figure B5. Cross sections of Burns Harbor North Breakwater, sta 0+00, 0+50, and 1+00

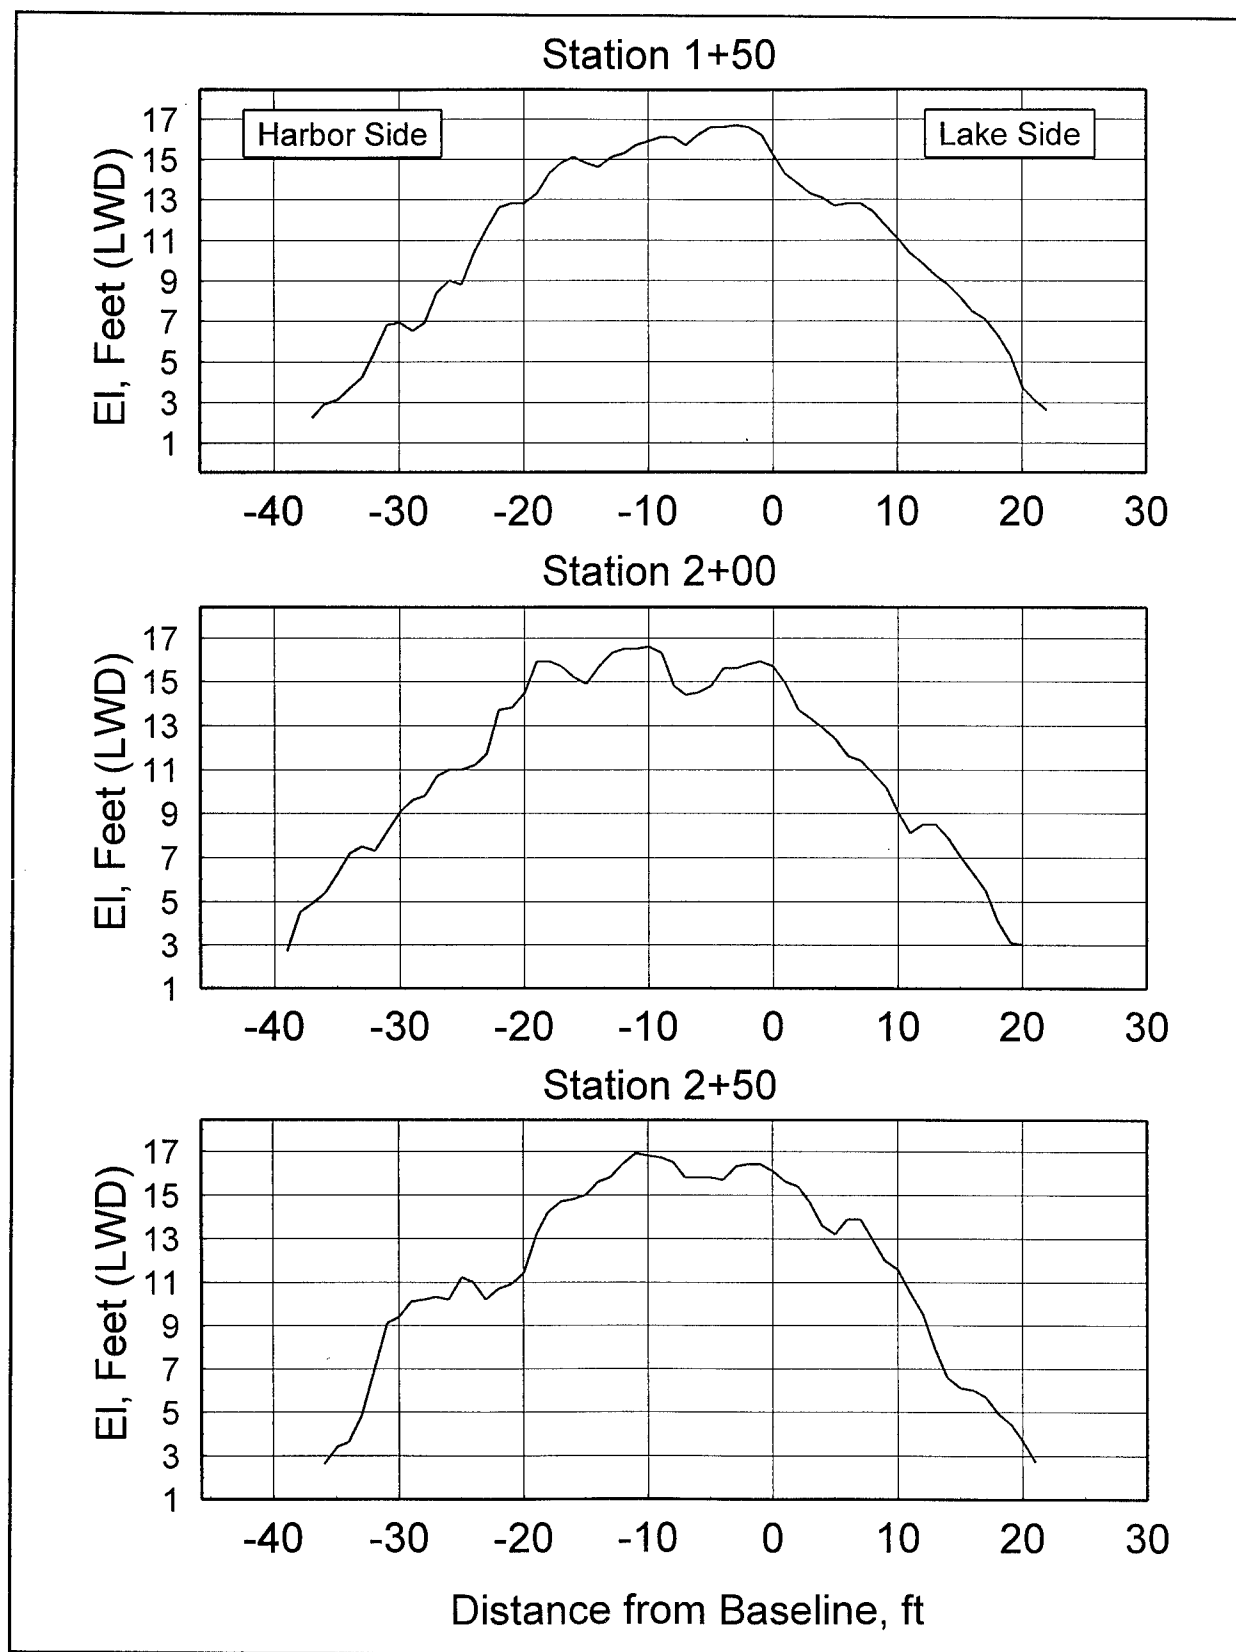
Figure B6. Cross sections of Burns Harbor North Breakwater, sta 1+50, 2+00, and 2+50

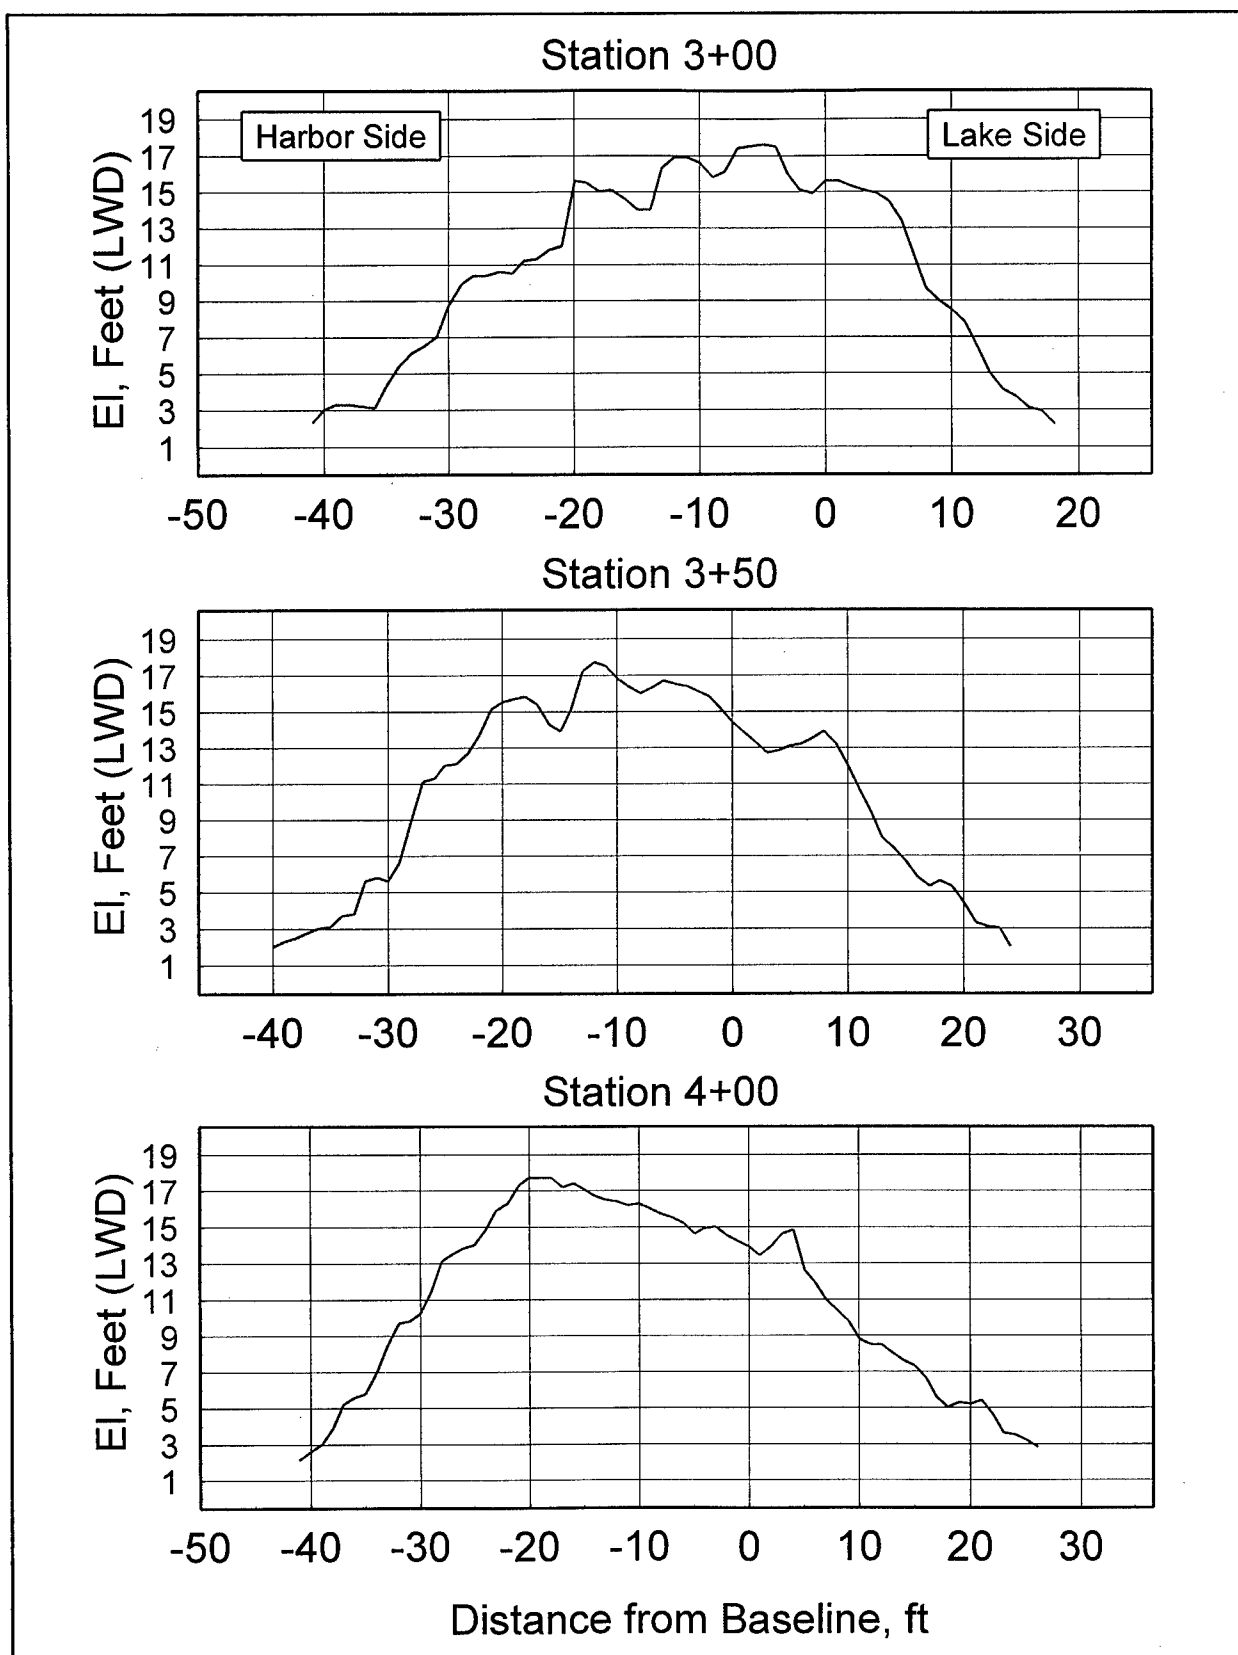
Figure B7. Cross sections of Burns Harbor North Breakwater, sta 3+00, 3+50, and 4+00
